RESEARCH ON LOAD CARRYING CAPACITY OF BASE TERRAINS OF THE WASTE DUMPS IN JIU VALLEY

Maria LAZAR, Prof.Ph.D., University of Petrosani
Adrian FLOREA, Assoc.Prof.Ph.D., University of Petrosani
Florin FAUR, Assist.Prof.Ph.D., University of Petrosani

ABSTRACT: Because the base terrains on which are located the waste dumps in Jiu Valley are different in terms of geological structure and form, overcoming their carrying capacity can lead to repressions or in extreme cases landslides. In cases where underneath the base terrains on which are located the waste dumps there are active or abandoned mining works interference may occur leading to a significant decrease in the initial carrying capacity. This paper examines the carrying capacity of the terrain on which are built the waste dumps storing large volumes of material.

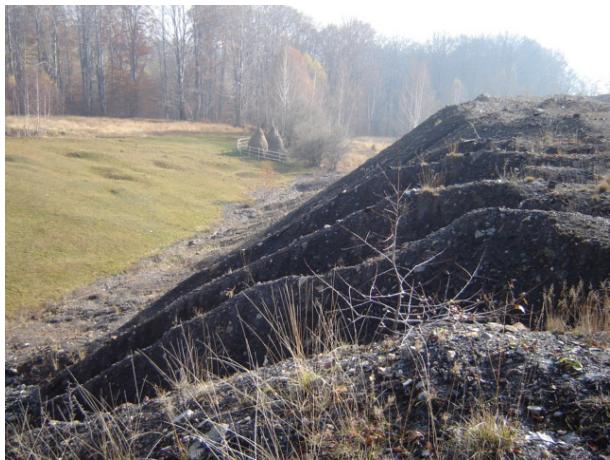
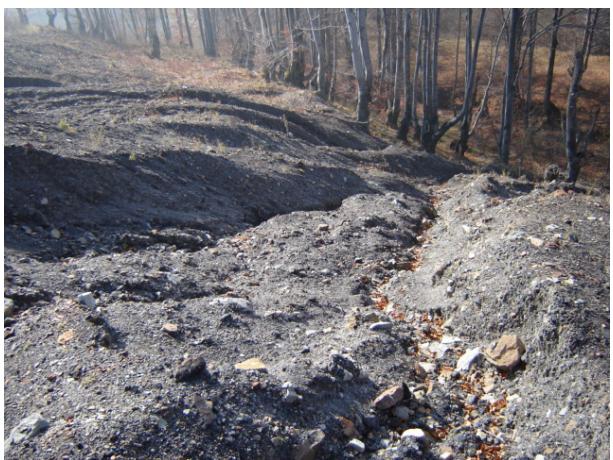
Erosion occurred as a result of mechanical action of surface water from rainfall and the lack of catchment and routing works, which led to the formation of gullies of different sizes, depending on the intensity of the runoff and the degree of compaction of the dumped material (photo 1).

Photo 1 Erosion phenomena on the northeastern (a) and southwestern (b) slope of the dump

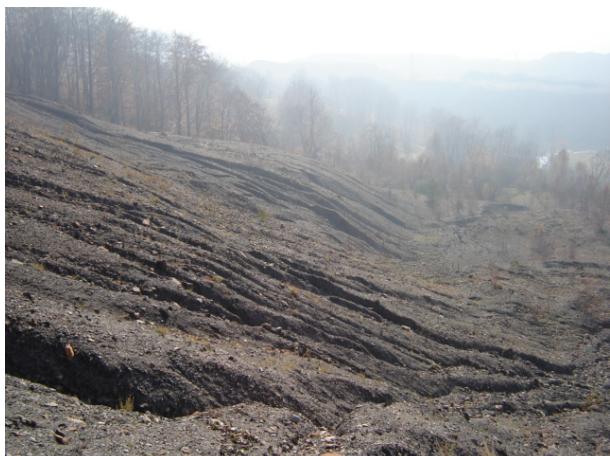
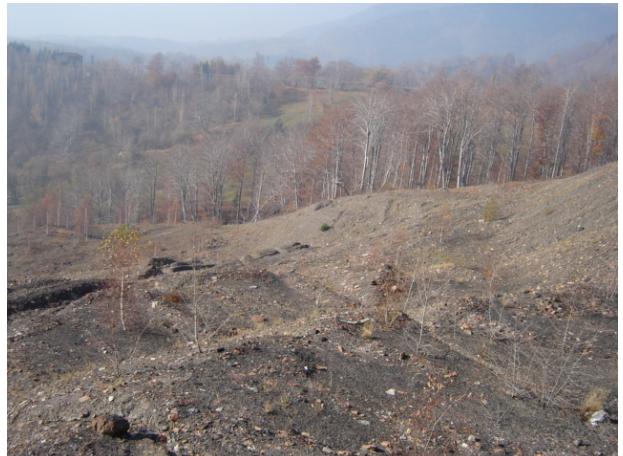
Discharge of rocks occurred in the base land, at the boundary of the slope sliding area in the southwest part of the dump (photo 2), and they occurred due to transmission of the slipping through the direct foundation (topsoil) by pushing rocks from the bottom of the dump [5].

Photo 2 Discharge of rocks through the base land in the slipping area

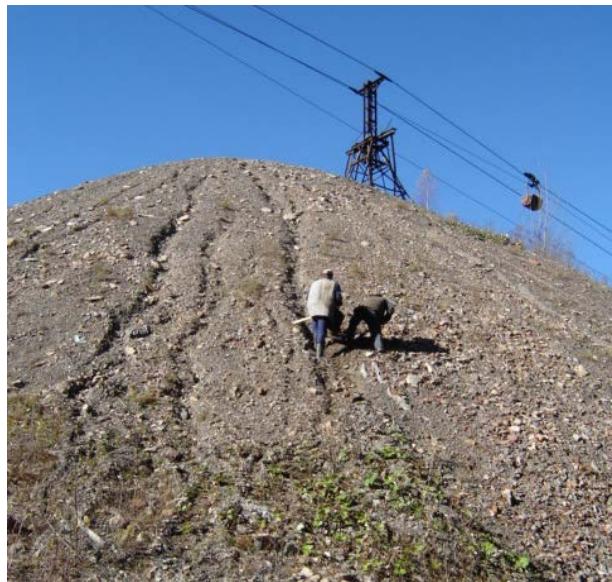
Erosion occur as a result of training the dumped material by runoffs, the dump being affected by such events on the side slopes (photo 3).

Photo 3 Erosion phenomena

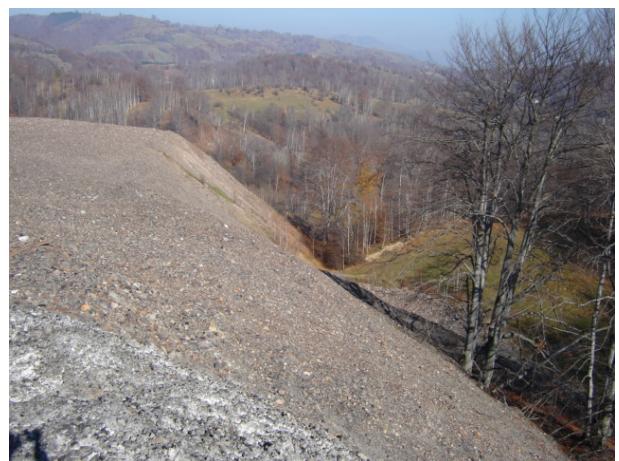
In terms of geometry, the waste dump is characterized by high values of the height and slope angle (often exceeding 30 m height and the slope angles are between 30 - 43° (photo 4). Due to geometric elements, land's morphology and by worsening the physical and mechanical characteristics of the deposited rock and the rocks from the direct foundation (represented topsoil), rainfall and the existence of lakes from which water seeps under the dump, the eastern slope was affected for a number of slides that have expanded and covered the road in the area (photo 5) [5].

Photo 4 Eastern and western slopes

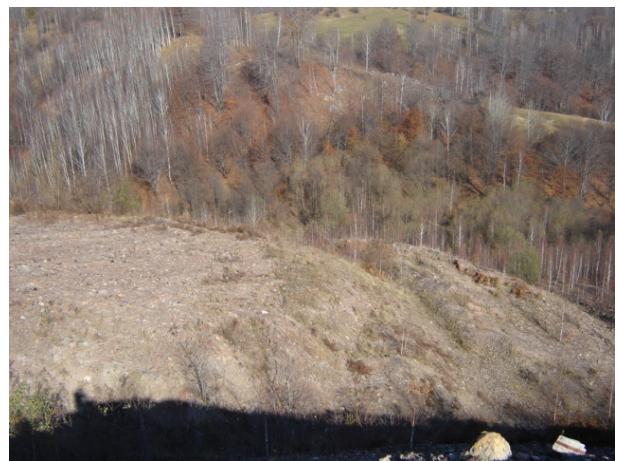
Photo5 Sliding area on the eastern slope

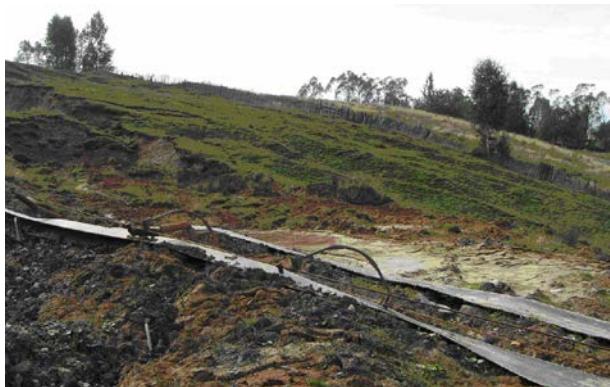
The old dump of Lonea mine is affected by phenomena of ruptures, curls, thrusts and plastic slides of the slope and plastic failure phenomena of the base land, particularly in the north-east (photo 6) [5]. At the base of the new dump there were identified a number of water reservoirs, which are located along the abandoned

Photo 6 Discharge phenomena and slope ruptures

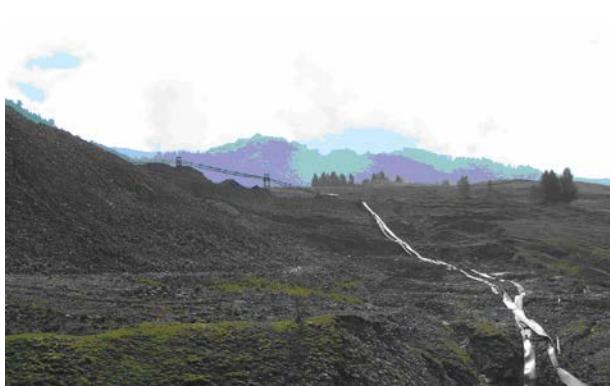
conveyor route on a NW-SE direction, over a distance of 30-50 m (photo 7). The status of tensions in the area is explained by the absence of an appropriate geometry, improper geometrical parameters of slopes (19-20 m height and inclination of 30°-50°) and the presence of water seepage at the contact between the dump and the base land.

Photo 7 Ruptures, slides, discharges and gullies
